Re: June 2017 Monthly Progress Report
Administrative Settlement Agreement and Order on Consent for Removal Action
U.S. EPA Region 10 Docket No. CERCLA 10-2009-0255
Gasco Sediments Site within the Portland Harbor Superfund Site

Attachment A Monthly Visual Monitoring Report for Pilot Cap Vicinity

Project: NW Natural – Gasco

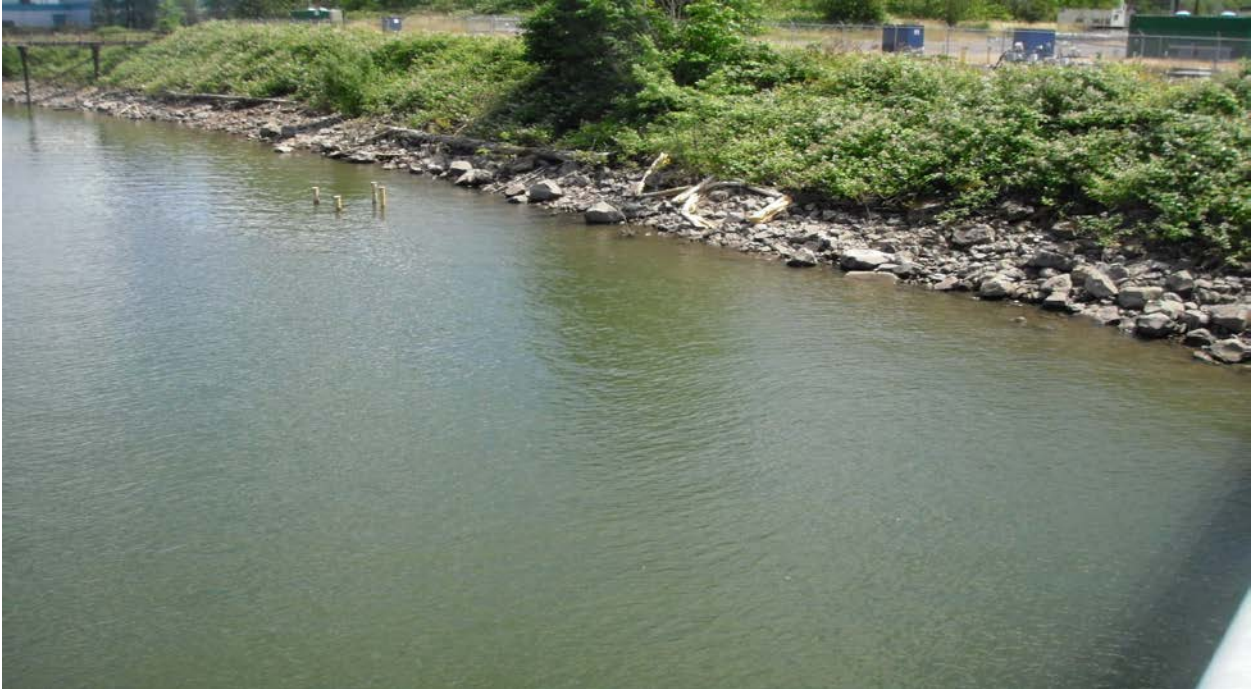
Photo 1

No erosion is evident along the shoreline. A few logs have deposited along the shoreline from past higher river elevation. The shoreward extent of the cap was not visible due to high river water elevation and the organoclay mat material shoreward of the cap area could not be observed (Photo 1).

River Level Currently Above the Extent of Sediment Cap (6/20/2017)

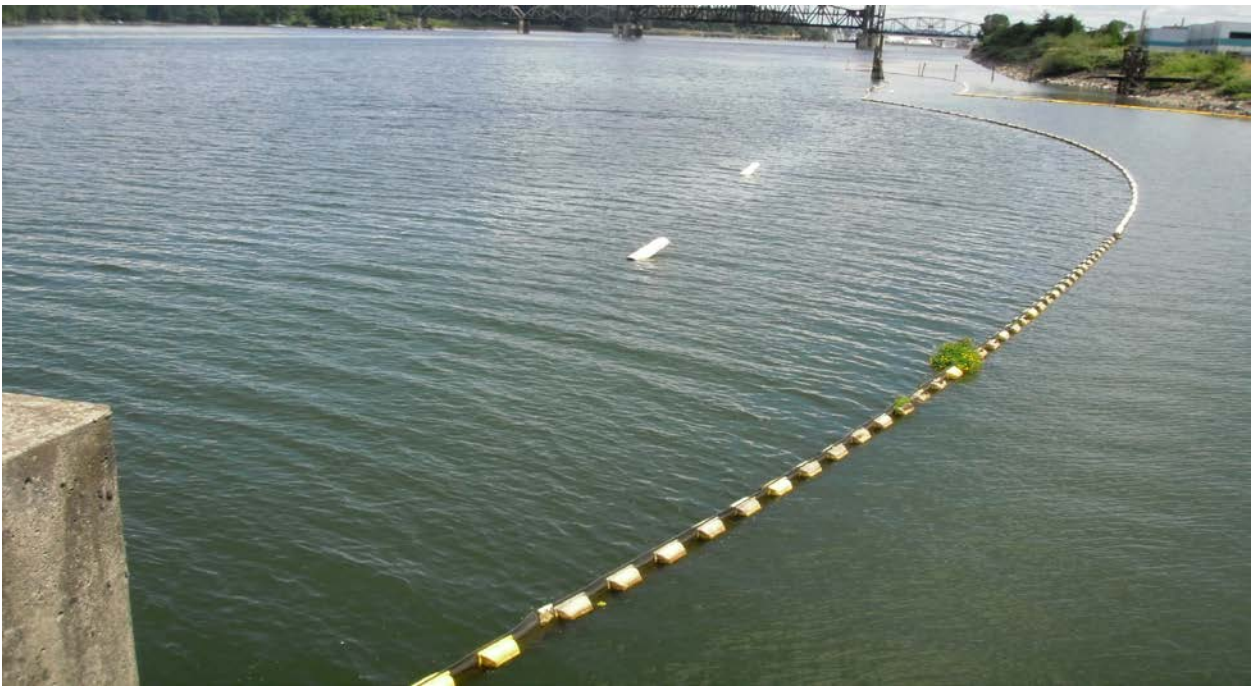
Photo 2

During the observation, the FAMM containment boom was placed across the cap area from the ship dock to the upriver dolphin. Two buoys that identify the cap area to mariners are in place as installed. The positions of the FAMM oil boom and warning buoys are shown in Photo 2.

FAMM Oil Boom Placement and Mariner Warning Buoys at Pilot Cap Area (6/20/2017)

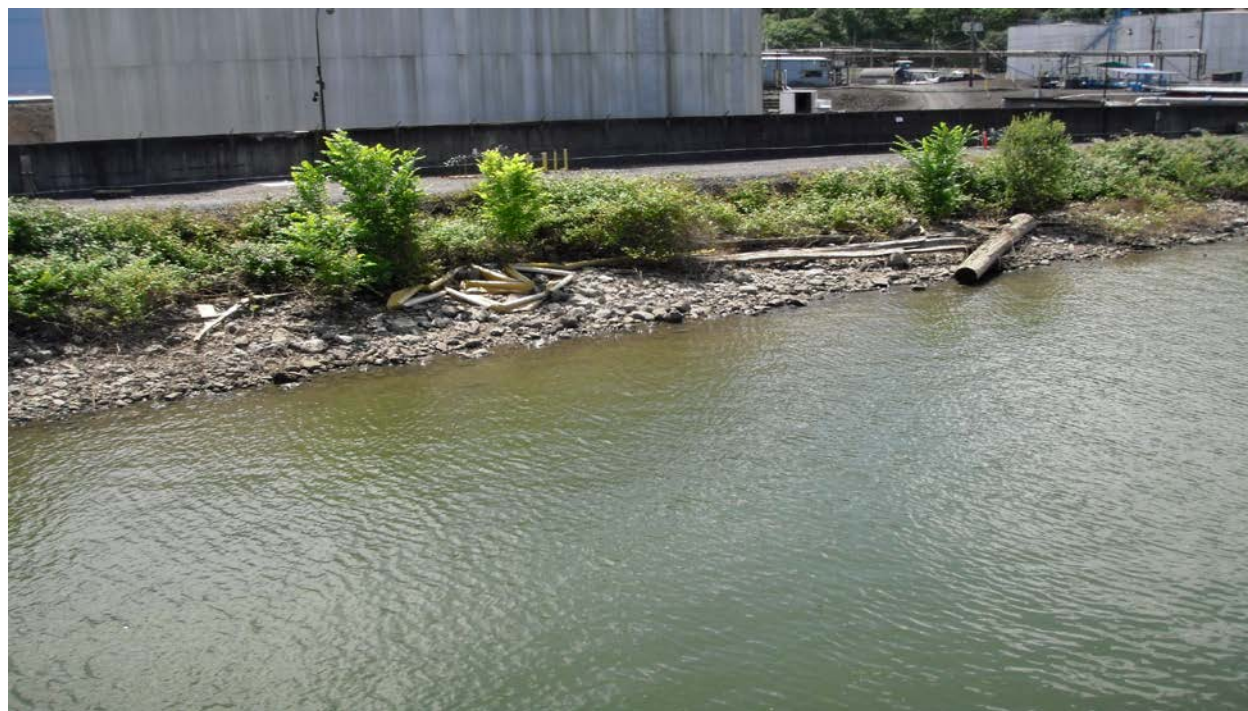
No sheen is evident in or around the cap area. Photo 3 shows the water surface and shoreline immediately downriver of the sediment cap.

Conditions Immediately Downriver of Cap Area (6/20/17)
